# Manhole Inspection Summary

Manhole # S49M\_\_009MH

Insp Date: **9/16/09 11:37 AM**

**Location** Address: **802 Lakewood St.**

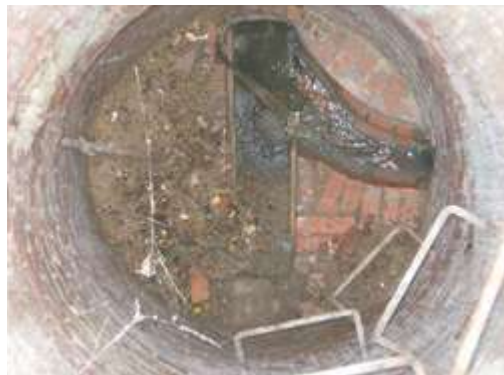
Top View

View facing west

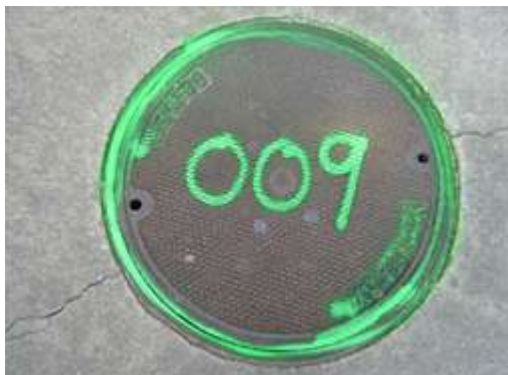
Miscellaneous

MH Lid

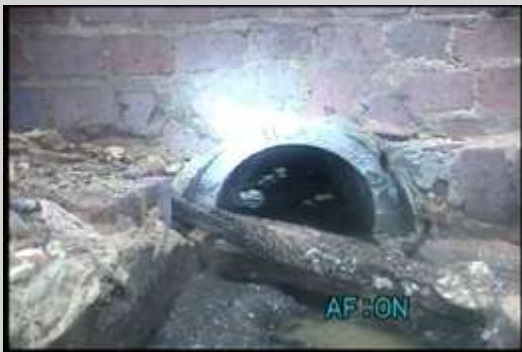
12 O'Clock Outflow

8 in. Circular Gravity Sewer  
Pipe Out @ 12 O'Clock

Pipe Height: **8.4** (in.) Rod and Bar (Angled)  
Pipe Material: **Clay** ☐ Pipe Lined  
Invert Depth: **9.60** (ft.) Flow Characteristics: **None**  
Deposits: ☒ None ☐ Mud ☐ Sludge ☐ Debris ☐ Grease  
Silt Depth: **0** (in.) Deposits Extent:  
Infiltration: **None** Pipe Seal Cond: **Sound**

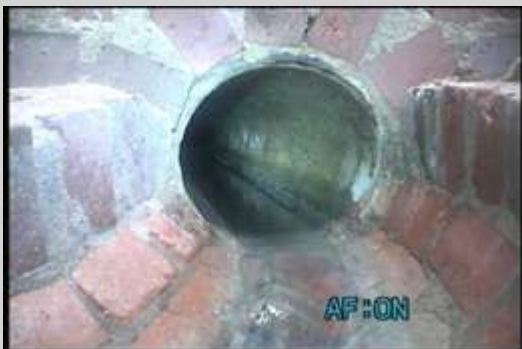
3 O'Clock Inflow

8 in. Circular Gravity Sewer  
Pipe In @ 3 O'Clock

Pipe Height: **8.4** (in.) Rod and Bar (Angled)  
Pipe Material: **Clay** ☐ Pipe Lined  
Invert Depth: **9.40** (ft.) Flow Characteristics: **None**  
Deposits: ☒ None ☐ Mud ☐ Sludge ☐ Debris ☐ Grease  
Silt Depth: **0** (in.) Deposits Extent:  
Infiltration: **None** Pipe Seal Cond: **Sound**
